Arkema Facility - Harvey Response

Crosby, TX

September 3, 2017

Project #109489 Summary

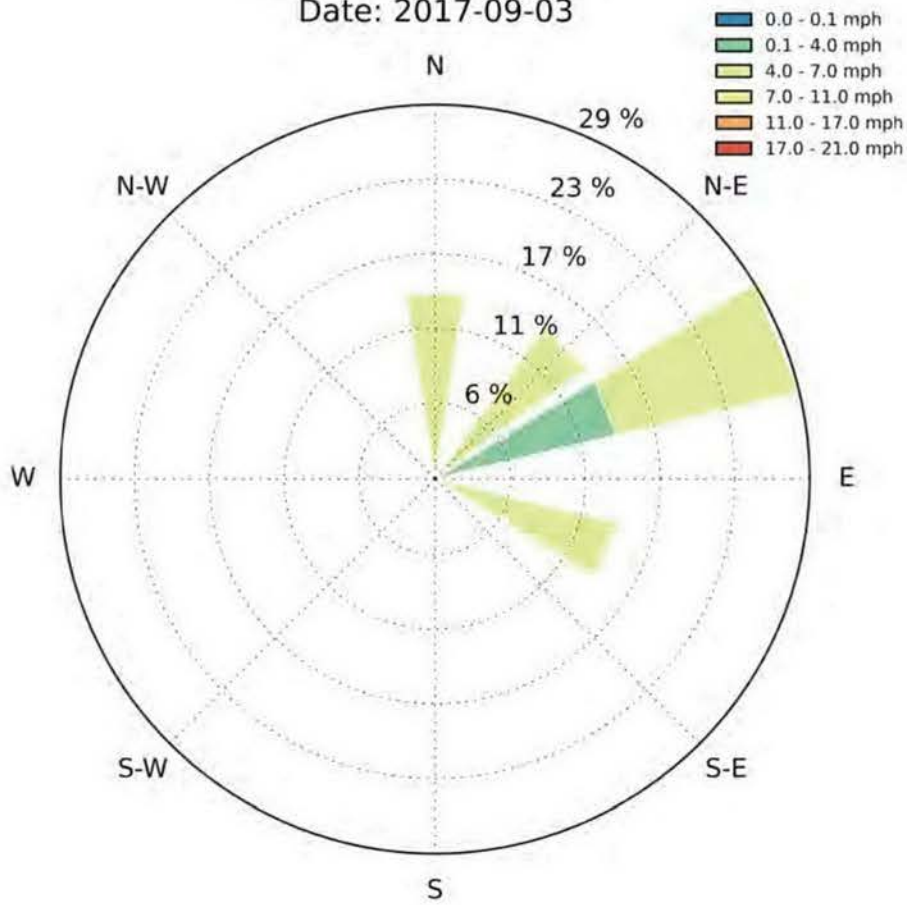
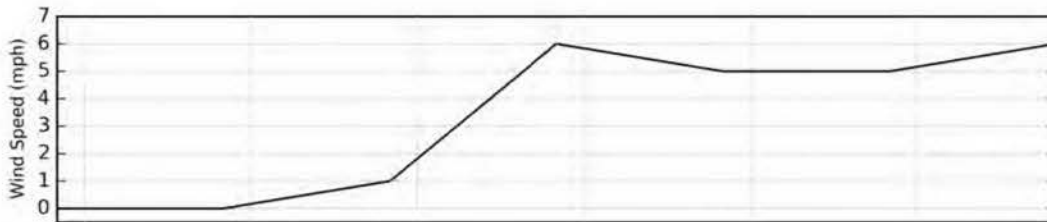
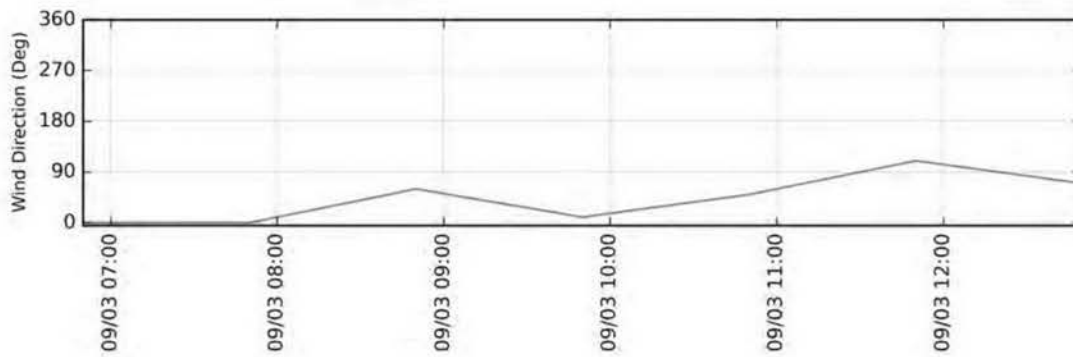
Weather Station: KHPY
Date: 2017-09-03

KHPY Windrose

(Highland Park Airport - 12.5 miles SSE of Site)
